Manhole Inspection Summary

Manhole # S23WW1014MH

Insp Date: **6/2/07 11:11 AM**

Location Address: **401 EDGEVALE RD**

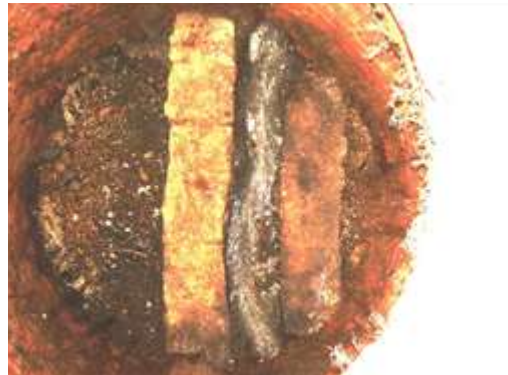
Top View

Condition: ☐ Sound ☐ Cracked ☒ **Root Intrusion** ☐ Loose Brick ☐ Deteriorated

Infiltration: ☐ None ☐ Joint ☐ Cracks ☒ **Mortar** ☒ **Roots** ☒ **Wall**

Corbel root intrusion and infiltration.
Bench debris.

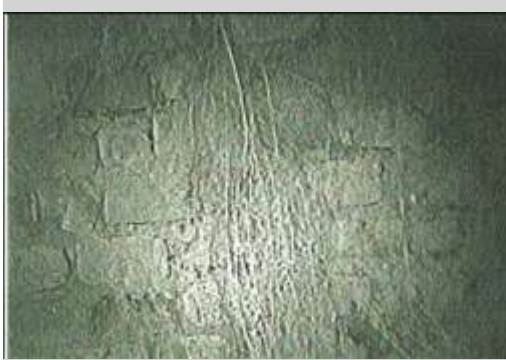
Defect

Condition: ☐ Sound ☐ Cracked ☒ **Root Intrusion** ☐ Loose Brick ☒ **Deteriorated**

Infiltration: ☐ None ☐ Joint ☐ Cracks ☒ **Mortar** ☒ **Roots** ☐ Wall

Barrel root intrusion, deterioration and
infiltration.

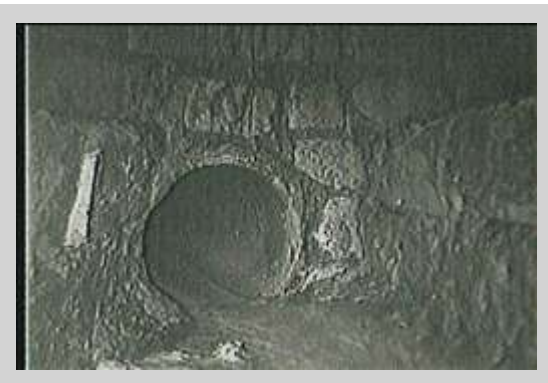
6 in. Circular Gravity Sewer Pipe In @ 6 O'Clock

Condition: ☐ Sound ☐ Cracked ☐ Root Intrusion ☒ **Deteriorated** ☐ Leaks ☐ Debris

Barrel deterioration and infiltration. Channel deterioration.
